FLOATING PARTICULATE FOUND

SPECIALIZED DESANDERS INC.™

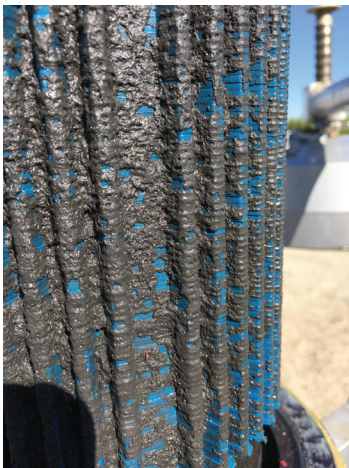
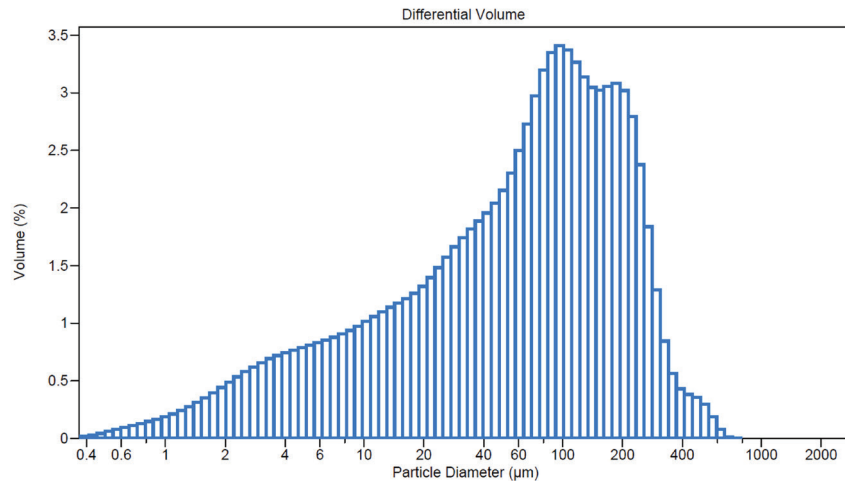
The Specialized Desanders Inc client was using a gravity-based Desander and there was evidence of floating particulate upon a field inspection. When fluid was drained from the Desander and into the containment tub, the particulate was still floating on the surface of the fluid over 24 hours later. This floating particulate showed up months after the well had already been in production.

This resulted in one of the best performances to date, particles blocked were below 1 micron. The SynPOL barrier was able to stop the gel emulsion/polymer that started to show up approximately 9 months after the well was put into production.

When the SynPOL was installed, the production rates of the well were around 160-180 E3/m3/d gas, 18m3/d condensate/water 50/50 cut and 3800 kPa flowing pressure. The initial differential pressure after the first SynPOL back flush clean out was around 37 kPa through the SynPOL.
